**[Docket No. FAA-2013-0340; Directorate Identifier 2010-SW-081-AD]**

**Airworthiness Directives; Eurocopter Deutschland GmbH Helicopters**

**ACTION:** Notice of proposed rulemaking (NPRM).

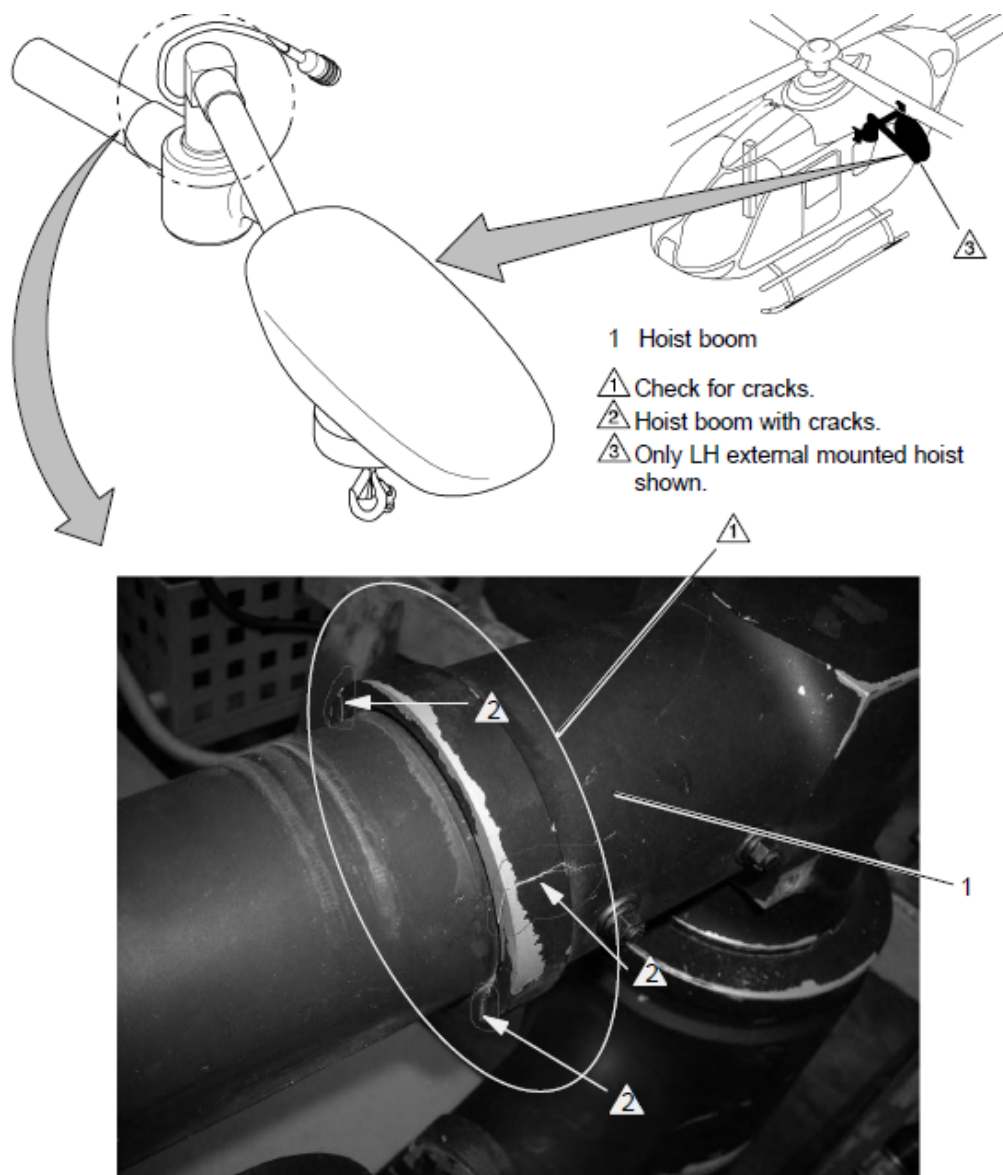
Figure 1 to Paragraph (e)

This AD defines the unsafe condition as a crack in the boom. This condition could result in loss of the boom and attached loads, and subsequent loss of helicopter control.

(1) Before further flight, and thereafter before the first flight of each day until you have performed the inspection required by paragraph (e)(2) of this AD, clean the hoist and visually check for a crack, paying particular attention to the areas that are circled as depicted in Figure 1 to paragraph (e) of this AD. The actions required by this paragraph may be performed by the owner/operator (pilot) holding at least a private pilot certificate, and must be entered into the aircraft records showing compliance with this AD in accordance with 14 CFR §§ 43.9 (a)(1)-(4) and 14 CFR § 91.417 (a)(2)(v). The record must be maintained as required by 14 CFR § 91.417, 121.380, or 135.439.

(2) Within 30 days, perform a dye penetrant inspection of the boom in accordance with the Accomplishment Instructions, Section 2.D, of the Goodrich Service Bulletin 44307-500-03, Revision 2, dated April 30, 2010 (SB).

(3) If a crack exists in the boom, replace the cracked boom with an airworthy boom before further flight.
